# Manhole Inspection Summary

Manhole # S35WW1011MH

Insp Date: 1/30/07 1:24 PM

**Location** Address: **319 TUNBRIDGE RD**

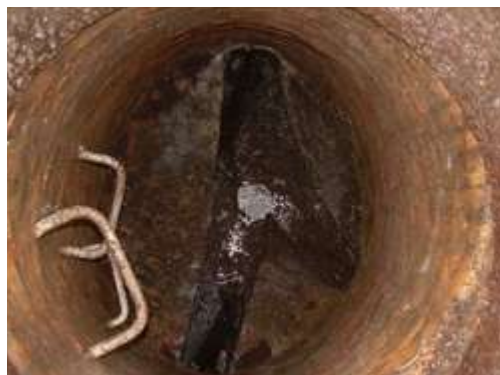
Top View

**Surcharge** ☒ **Evidence Of Surcharge** Depth: **1.5** (ft.) ☐ Active Surcharge Present

Evidence of surcharge - Bench debris.  
Channel debris.

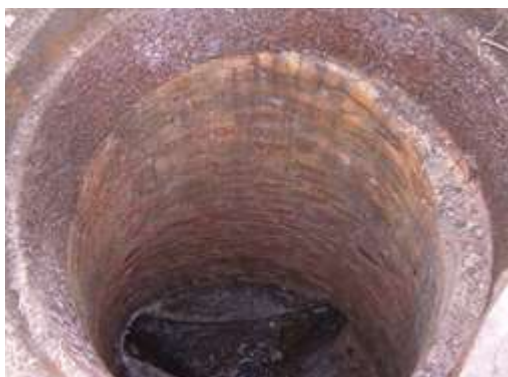
Defect

Frame leaks. Frame offset. Adjustment  
deterioration and infiltration. Barrel  
infiltration.

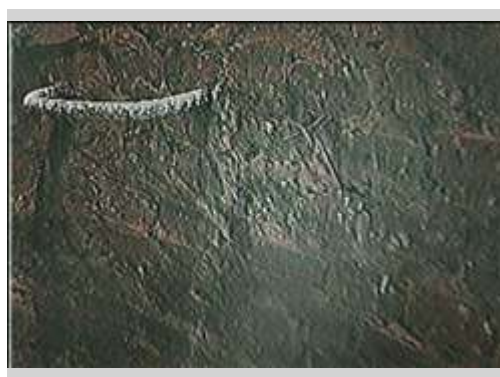
Defect

Barrel root intrusion, deterioration and  
infiltration.

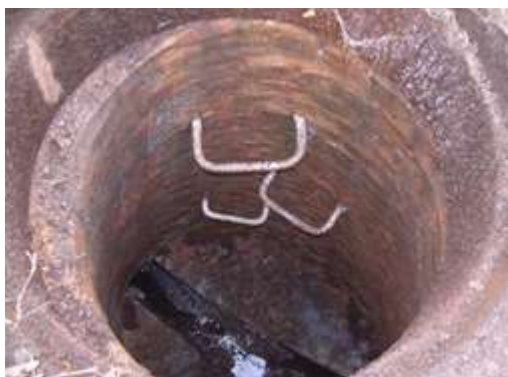
Defect

Frame leaks. Frame offset. Adjustment  
and Barrel infiltration - other side.

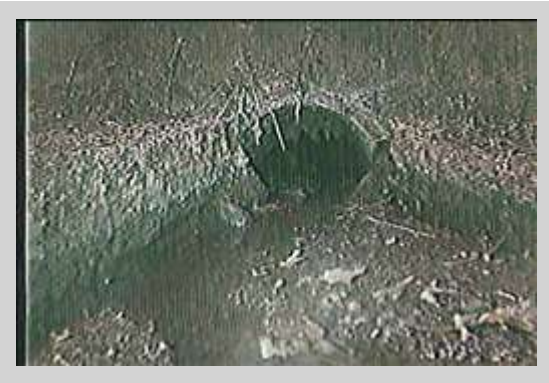
### 8 in. Circular Gravity Sewer Pipe Out @ 12 O'Clock

Channel deterioration.

Deposits: ☐ None ☒ **Mud** ☐ Sludge ☒ **Debris** ☐ Grease

Infiltration: **Evidence** Pipe Seal Cond: **Roots**

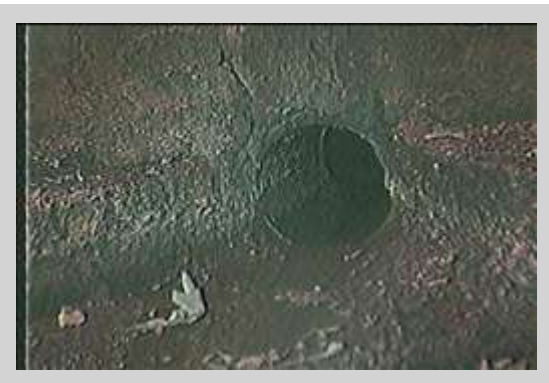
### 6 in. Circular Gravity Sewer Pipe In @ 4 O'Clock

Deposits: ☐ None ☐ **Mud** ☐ Sludge ☒ **Debris** ☐ Grease

Infiltration: **Evidence** Pipe Seal Cond: **Cracked**

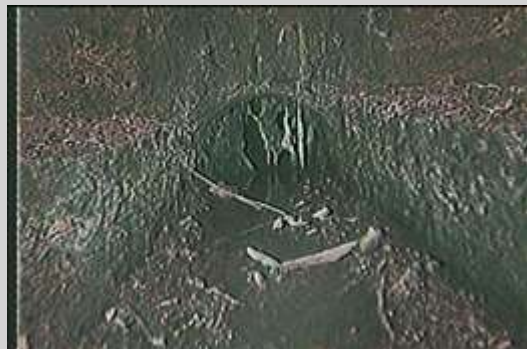
Pipe In @ 7 O'Clock

Barrel deterioration, root intrusion and infiltration.

Deposits: ☐ None ☒ **Mud** ☐ Sludge ☒ **Debris** ☐ Grease

Pipe Seal Cond: **Roots**
